Project / Plant: Water tightness test of the plastic flange Hauff HSI150-DFK for retrofit dowelling onto a waterproof concrete test block

Product description: Plastic flange Hauff HSI150-DFK for retrofit dowelling

Order: Water tightness test $\geq 1,0$ bar for 28 days, subsequent $\geq 2,0$ bar for 1 day and $\geq 2,5$ bar for another 1 day

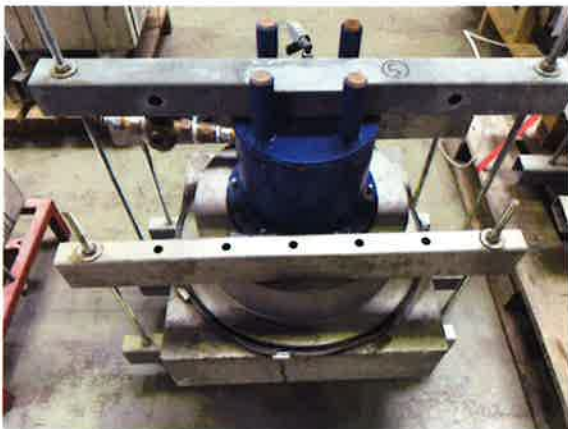
Figure 1. Assembled test setup.

Therefore Hauff-Technik GmbH & Co. KG delivered the concrete test block with the already installed plastic flange Hauff HSI150-DFK together with the components for the test setup to our test laboratory in Gersthofen, Germany. The assembly of the test setup was performed by an employee of Hauff-Technik GmbH & Co. KG (see Figure 1).

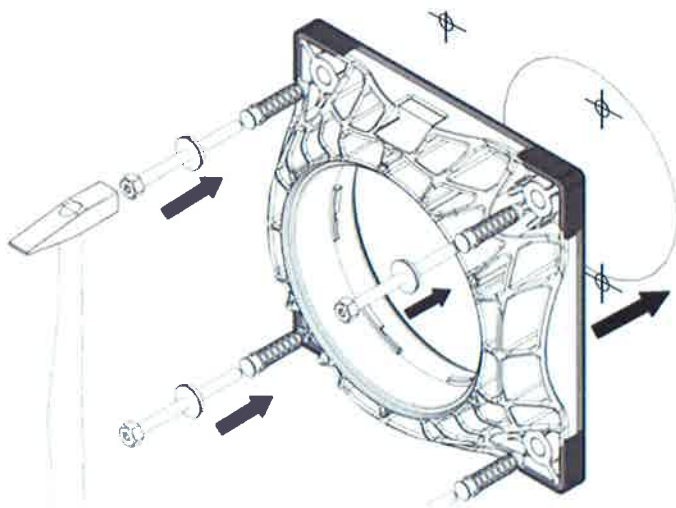
Figure 2. Example of installation of the plastic flange Hauff HSI150-DFK (picture of the manufacturer).

Then the flange was pressed onto the wall and the pre-installed screws with sealing disc and insert fastening dowels were hit in until the dowels were flush with the shaft (see Figure 2).

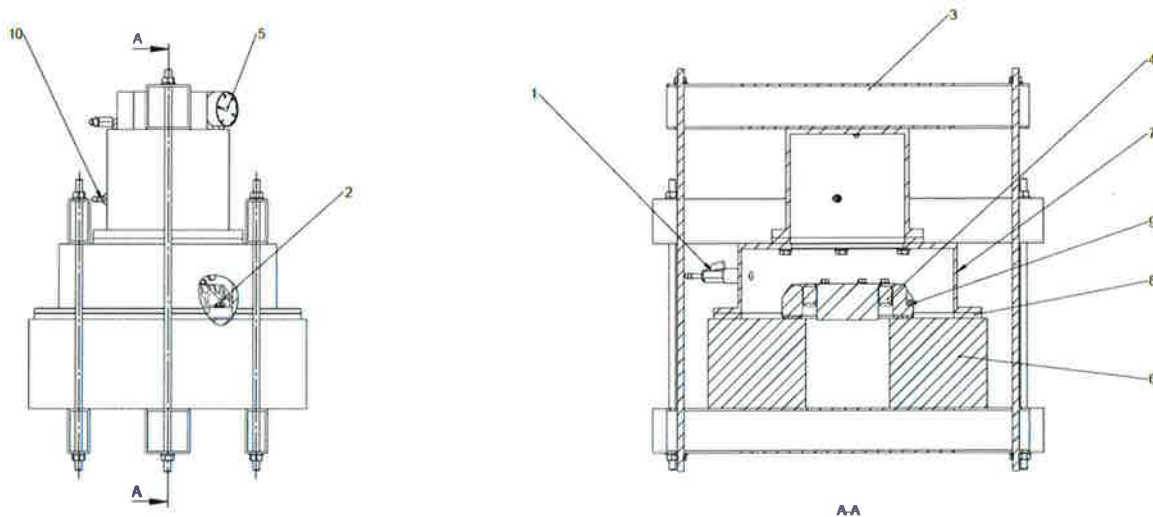
Position	Designation
1	stop valve
2	fixing plugs
3	security bar
4	press seal „HRD150/160-G-WE Z/d“
5	pressure gauge manometer
6	touchstone
7	test cylinder
8	test cylinder seal
9	plastic flange “HSI150-DFK”
10	air bleed valve

Figure 3. Detail of the test setup - manufacturer's drawing.

The test setup which was assembled by Hauff-Technik GmbH & Co. KG was built up in accordance to Section 3.1 with one manometer (see Figure 3).

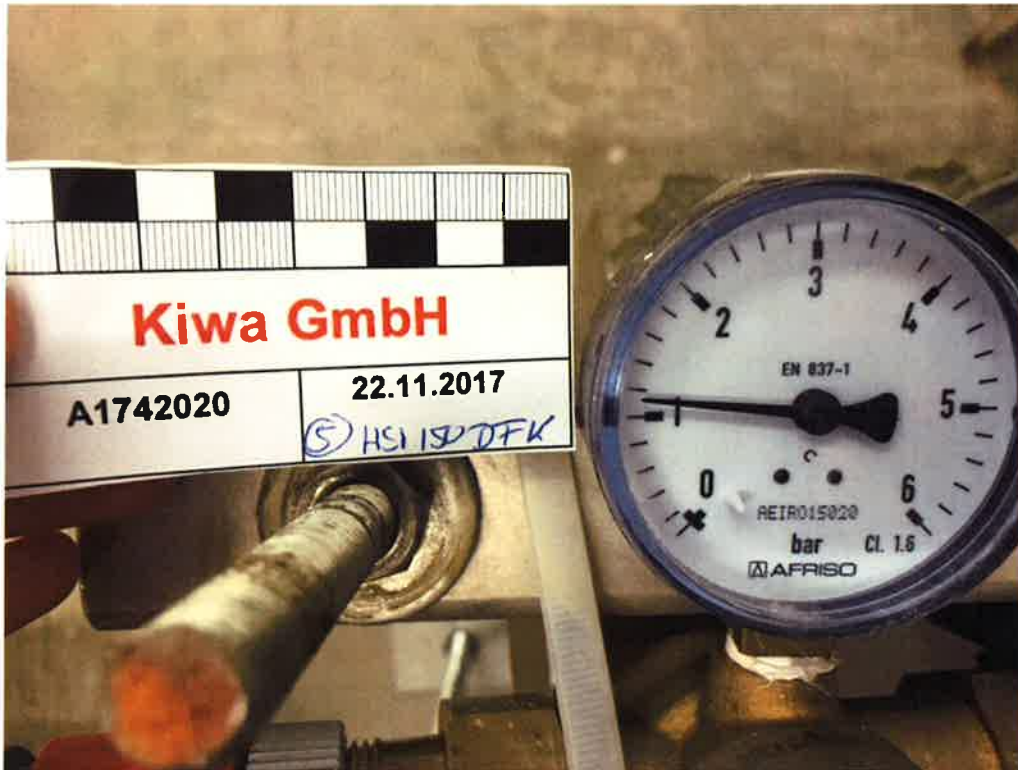
Figure A1. Water tightness test with $\geq 1,0$ bar water filled test cylinder (manometer at the beginning of testing on 22.11.2017).

During the water tightness test no pressure drop as a result of leakages was detected (see Table 1). The test results can be seen at Figure A1 to Figure A6 attached in the annex.

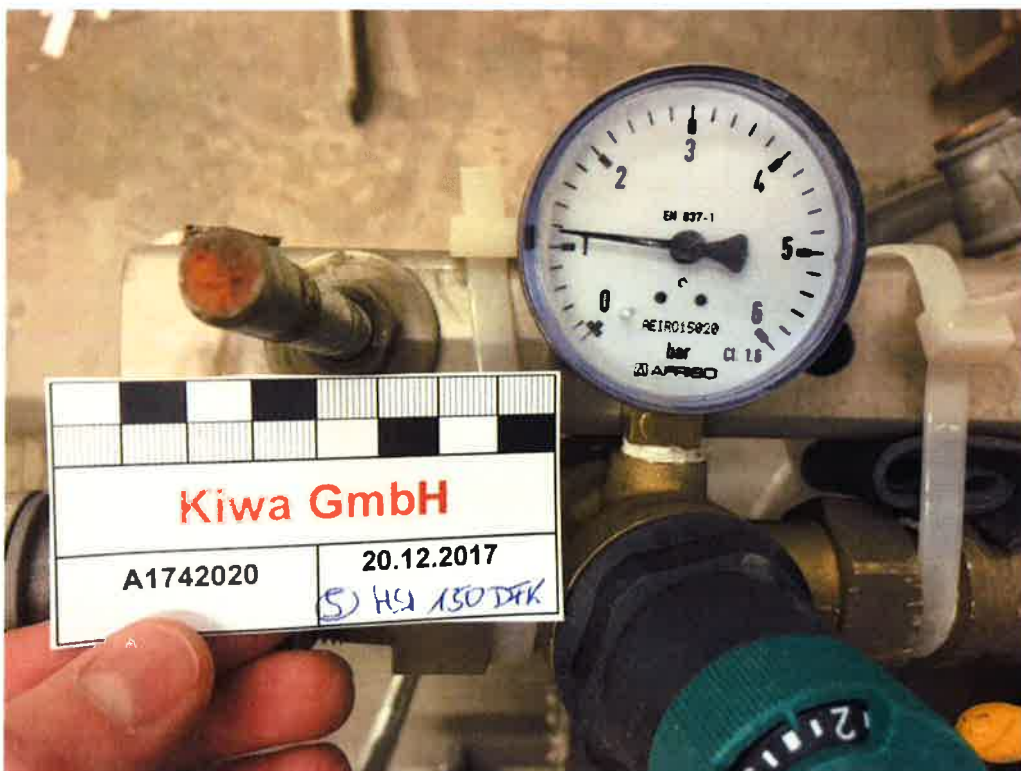
Figure A2. Water tightness test with $\geq 1,0$ bar water filled test cylinder (manometer after 28 days on 20.12.2017).

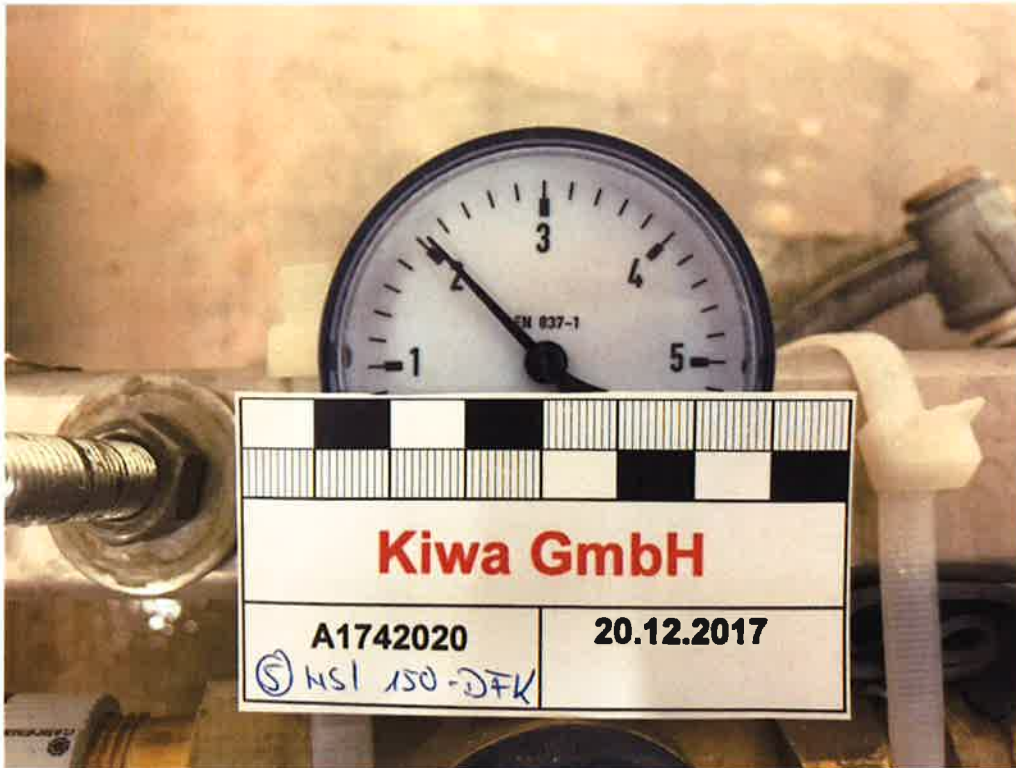
Figure A3. Water tightness test with $\geq 2,0$ bar water filled test cylinder (manometer at the beginning of testing on 20.12.2017).

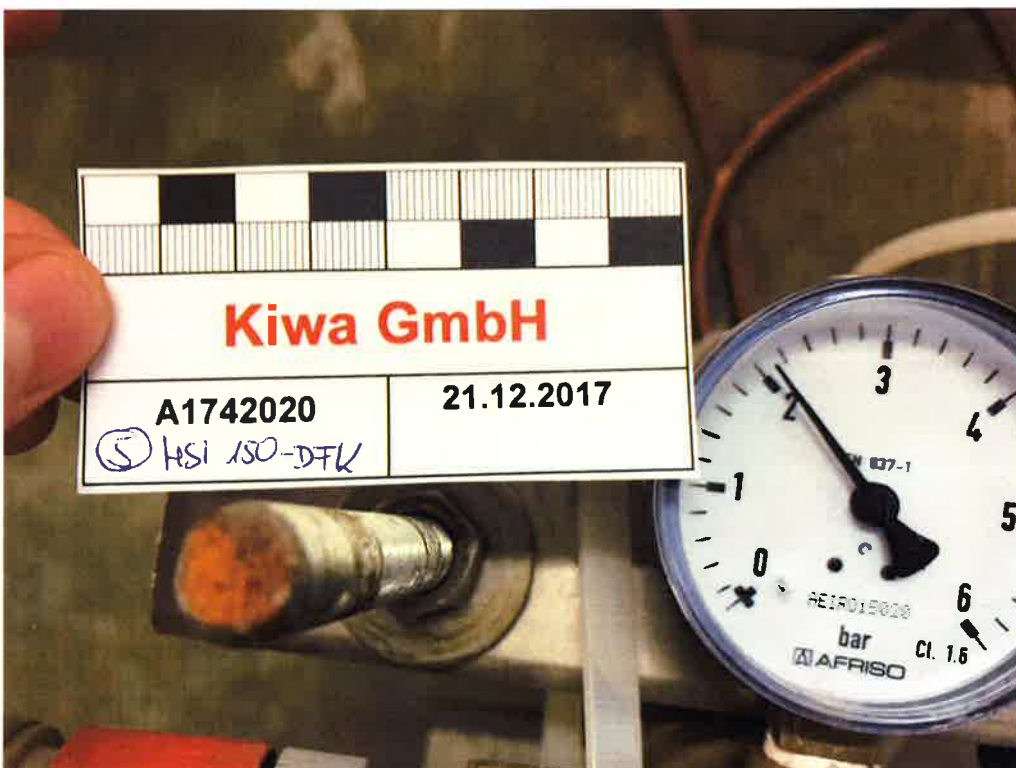
Figure A4. Water tightness test with $\geq 2,0$ bar water filled test cylinder (manometer > 24 hours on 21.12.2017).

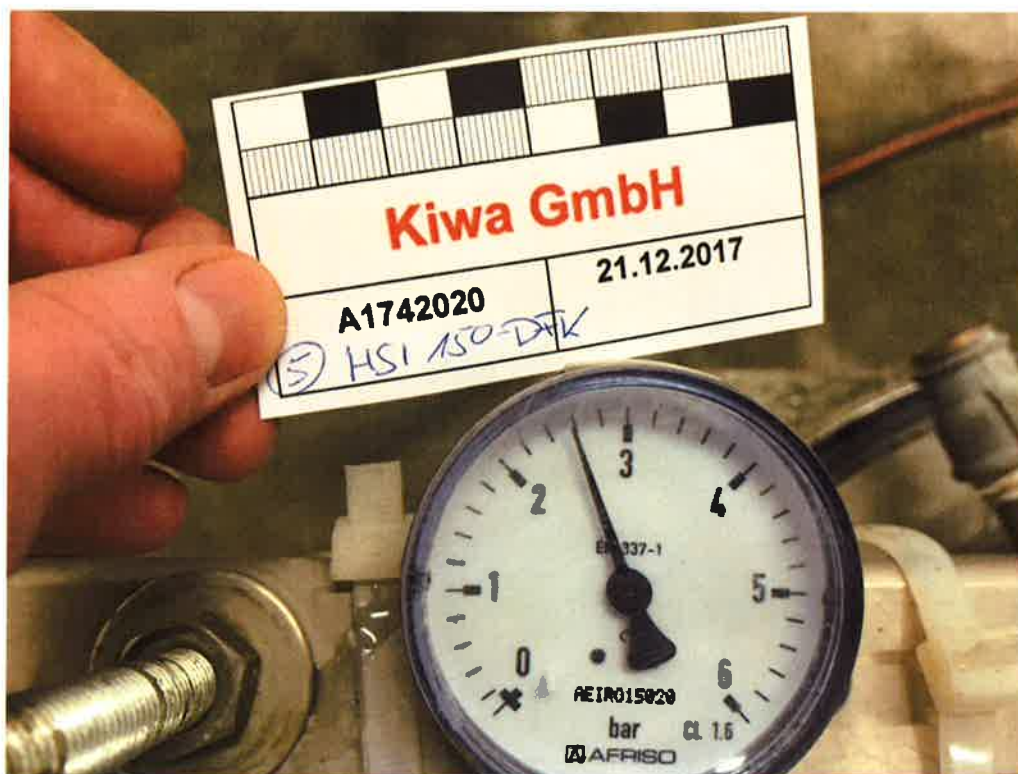
Figure A5. Water tightness test with $\geq 2,5$ bar water filled test cylinder (manometer at the beginning of testing on 21.12.2017).

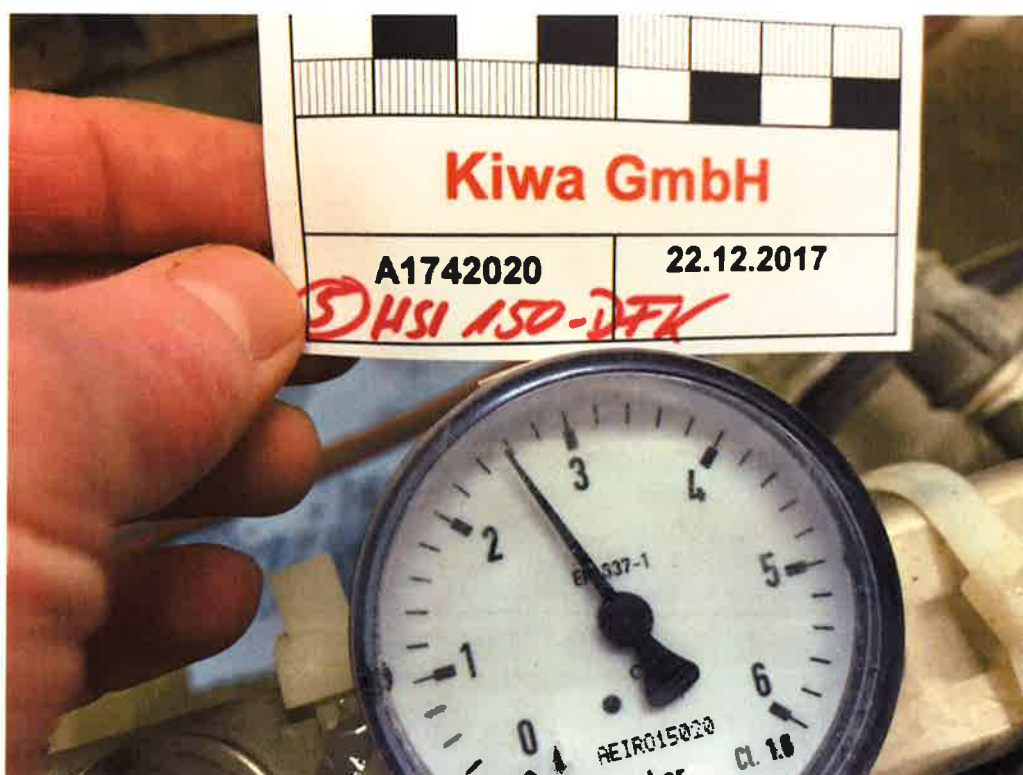
Figure A6. Water tightness test with $\geq 2,5$ bar water filled test cylinder (manometer > 24 hours on 22.12.2017).
