## Test Report

Contract : Testing of the water-tightness of the sealing system flange plate with HRD 150-F2-0 in core hole Ø 150 mm

Kiwa MPA Bautest GmbH was contracted by Hauff-Technik GmbH & Co. KG to evaluate the water tightness of flange plate with ring seal insert for use as house lead-in.

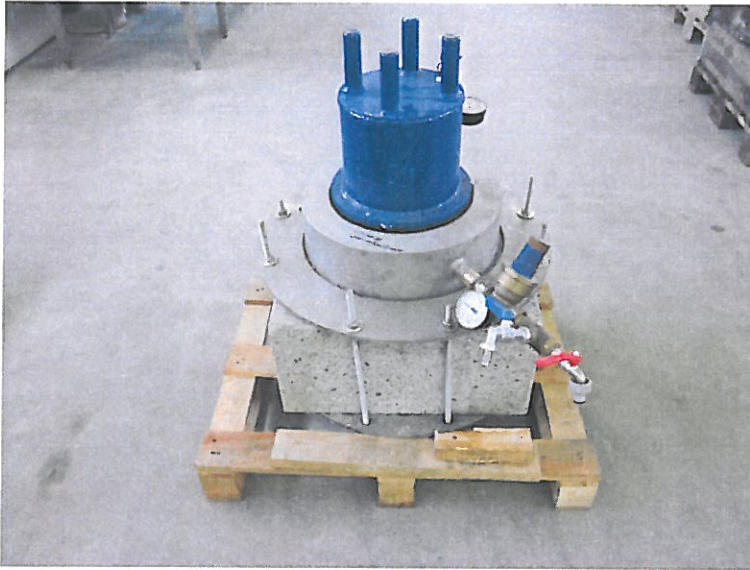
Figure 2: Test setup

The test member delivered by the Manufacturer was a pre-assembled test member with a test setup with pre-assembled manometer and pressure regulator in accordance with section 2.1 (see Figure 2 to Figure 5). A calibration of the manometer and the pressure regulator by Kiwa MPA Bautest GmbH was not carried out.

After consultation with the Manufacturer a tightness test with water filled pressure bell over a period of 24 h with a nominal pressure of 2,5 bar was carried out. The filling of the pressure bell with water was carried out until the water-level reached the inlet and the air bleed valve respectively.
